FACTORS CONTRIBUTING TO LANDSLIDE
ACTIVITY IN THE WINTER OF 1995-96,
CLEARWATER COUNTY NEAR OROFINO, IDAHO

A Thesis
Presented to
The Graduate Faculty
Central Washington University

by
Aaron Paul Wisher
November, 1998

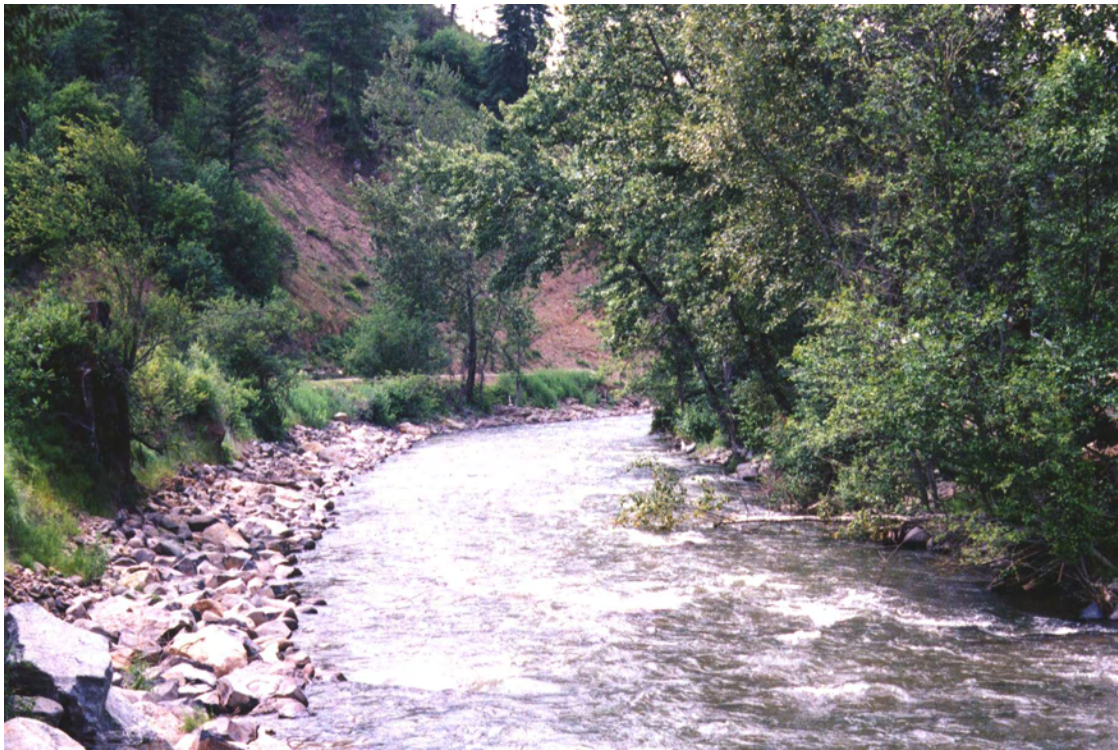
Figure 11: Photograph showing landslide site 23. (Notice mitigation of stream channel.)

The landslide at this site is relatively large with an estimated volume of over 600 cubic feet of displaced material. Orofino Creek flows at the base of this landslide (Figure 11). The landslide that initiated at this site is on a NE facing slope. The landform here is on a slope hollow. Steepness is more than 40-45%. There are natural springs approximately 5 feet from the top of the landslide.

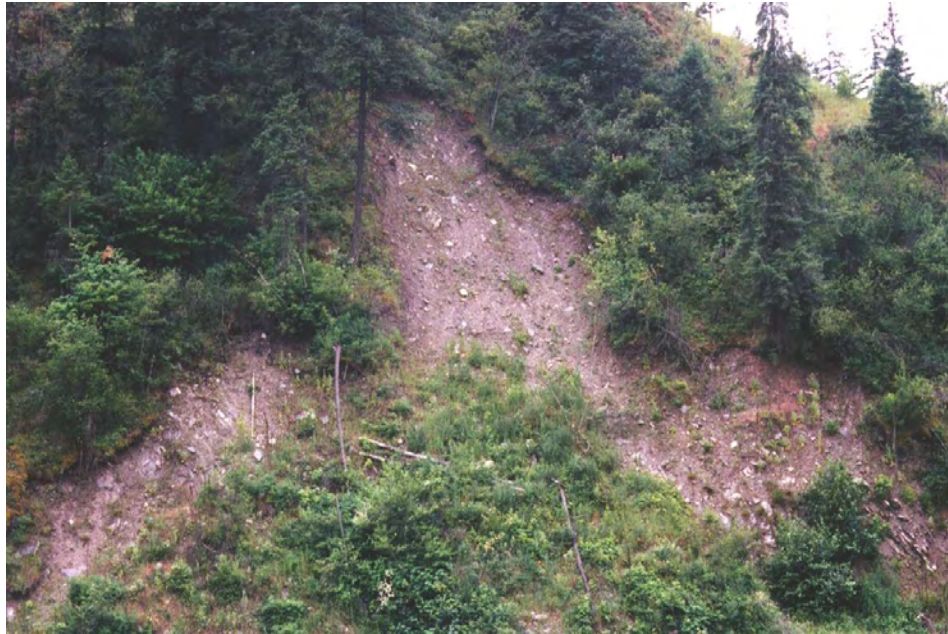
Figure 13: Photograph of landslide at site 26.

The landslide at this site is relatively large with an estimated volume of over 400 cubic feet of displaced material. Orofino Creek flows at the base of this landslide (Figure 13). The landslide that initiated at this site is on an ENE facing slope. The landform here is on a slope hollow. Steepness is more than 50%. There are natural springs approximately 5 feet from the top of the landslide.

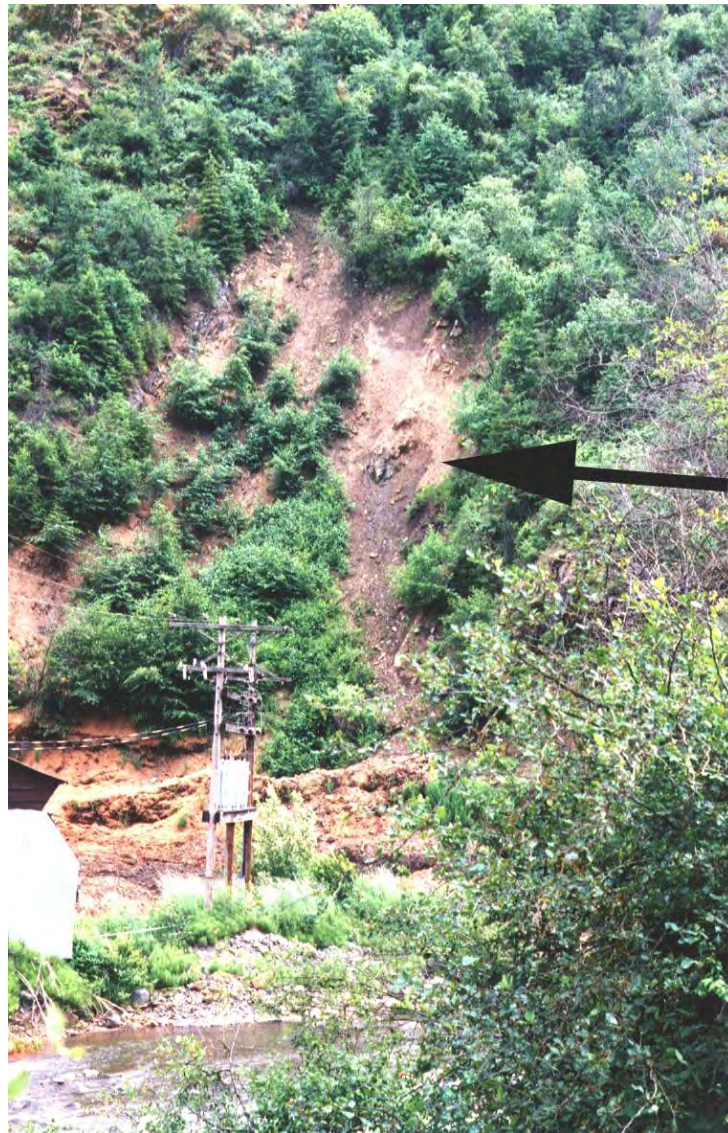
Figure 14: Photograph of landslide at site 27. Arrow indicates location of springs.

The landslide at this site is relatively large with an estimated volume of over 600 cubic feet of displaced material. Orofino Creek flows at the base of this landslide (Figure 14). The landslide that initiated at this site is on a NNE facing slope. The landform here is on a slope hollow. Steepness is more than 50%. There are natural springs approximately 5 feet from the top of the landslide.

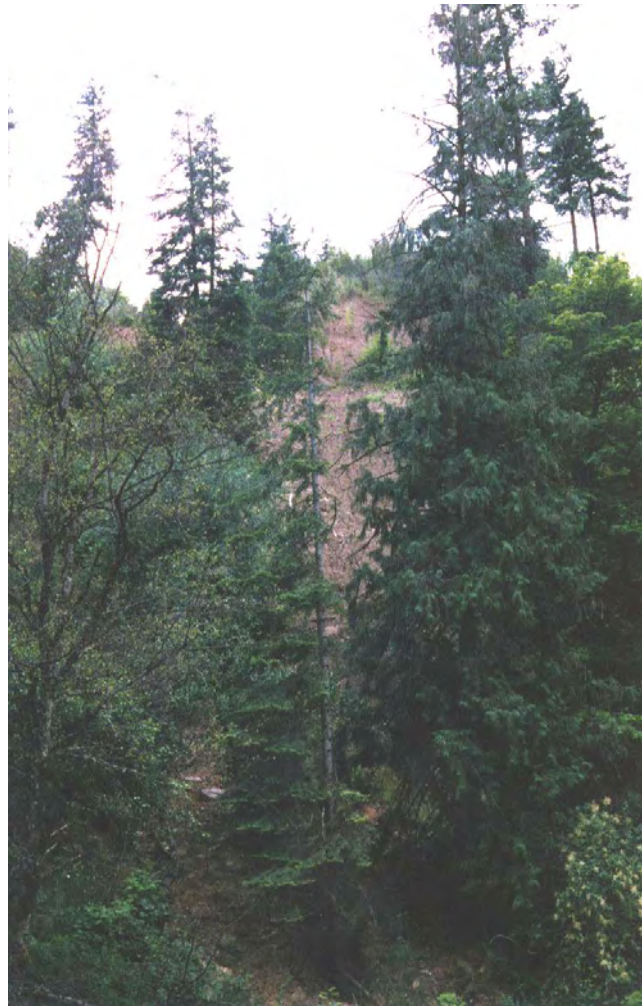
Figure 15: Photograph of landslide at site 28.

The landslide at this site is relatively large with an estimated volume of over 1100 cubic feet of displaced material. Orofino Creek flows at the base of this landslide (Figure 15). The landslide that initiated at this site is on a NW facing slope. The landform here is on a slope hollow. Steepness is more than 50%. There are natural springs approximately 5 feet from the top of the landslide.

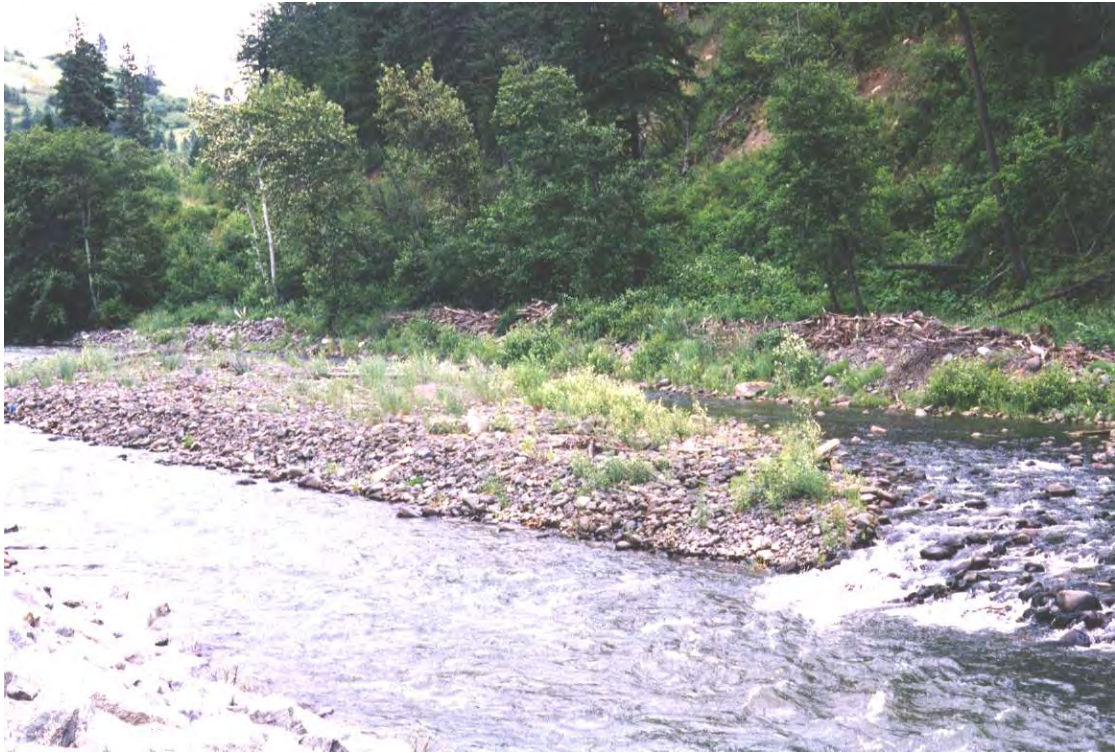
Figure 16: Photograph of debris levee formed from displaced material. Landslide site 30 in background (center).

The landslide at this site is relatively large with an estimated volume of over 800 cubic feet of displaced material. Orofino Creek flows at the base of this landslide (Figure 16). The landslide that initiated at this site is on a NW facing slope. The landform here is on a slope hollow. Steepness is more than 50%. There are natural springs approximately 5 feet from the top of the landslide.

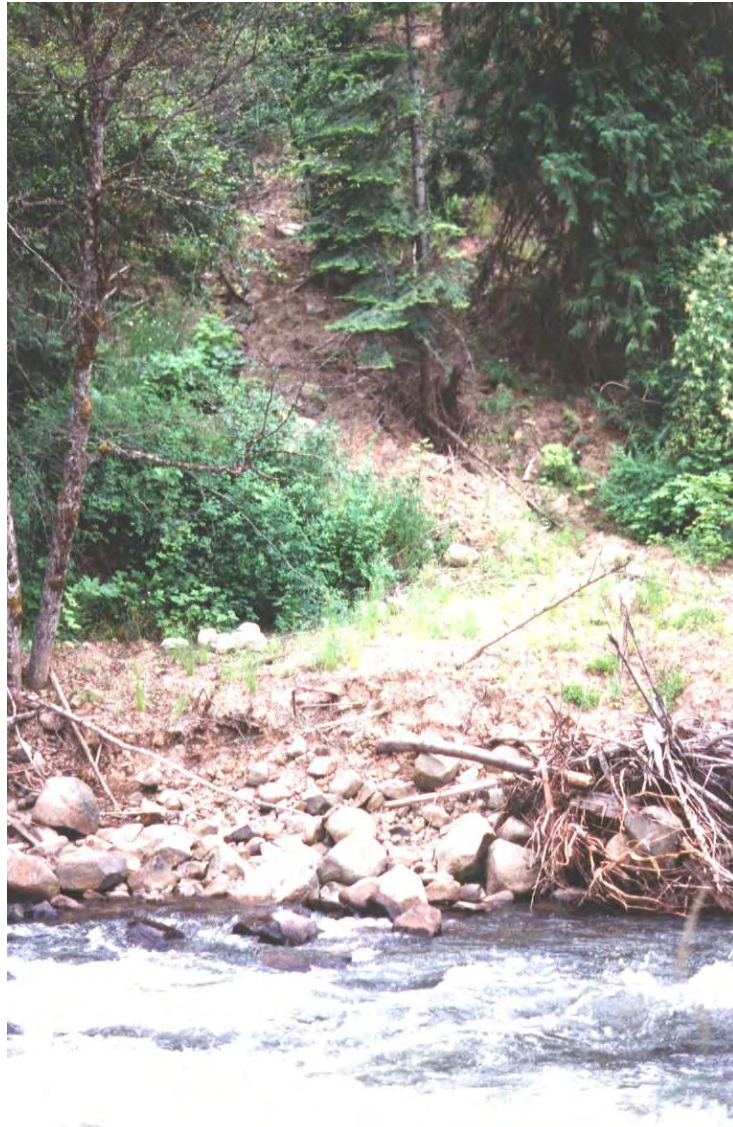
Figure 17: Photograph of Landslide at site 31.

The landslide at this site is relatively large with an estimated volume of over 600 cubic feet of displaced material. Orofino Creek flows at the base of this landslide (Figure 17). The landslide that initiated at this site is on a north-facing slope. The landform here is on a slope hollow. Steepness is more than 50%. There are natural springs approximately 5 feet from the top of the landslide.

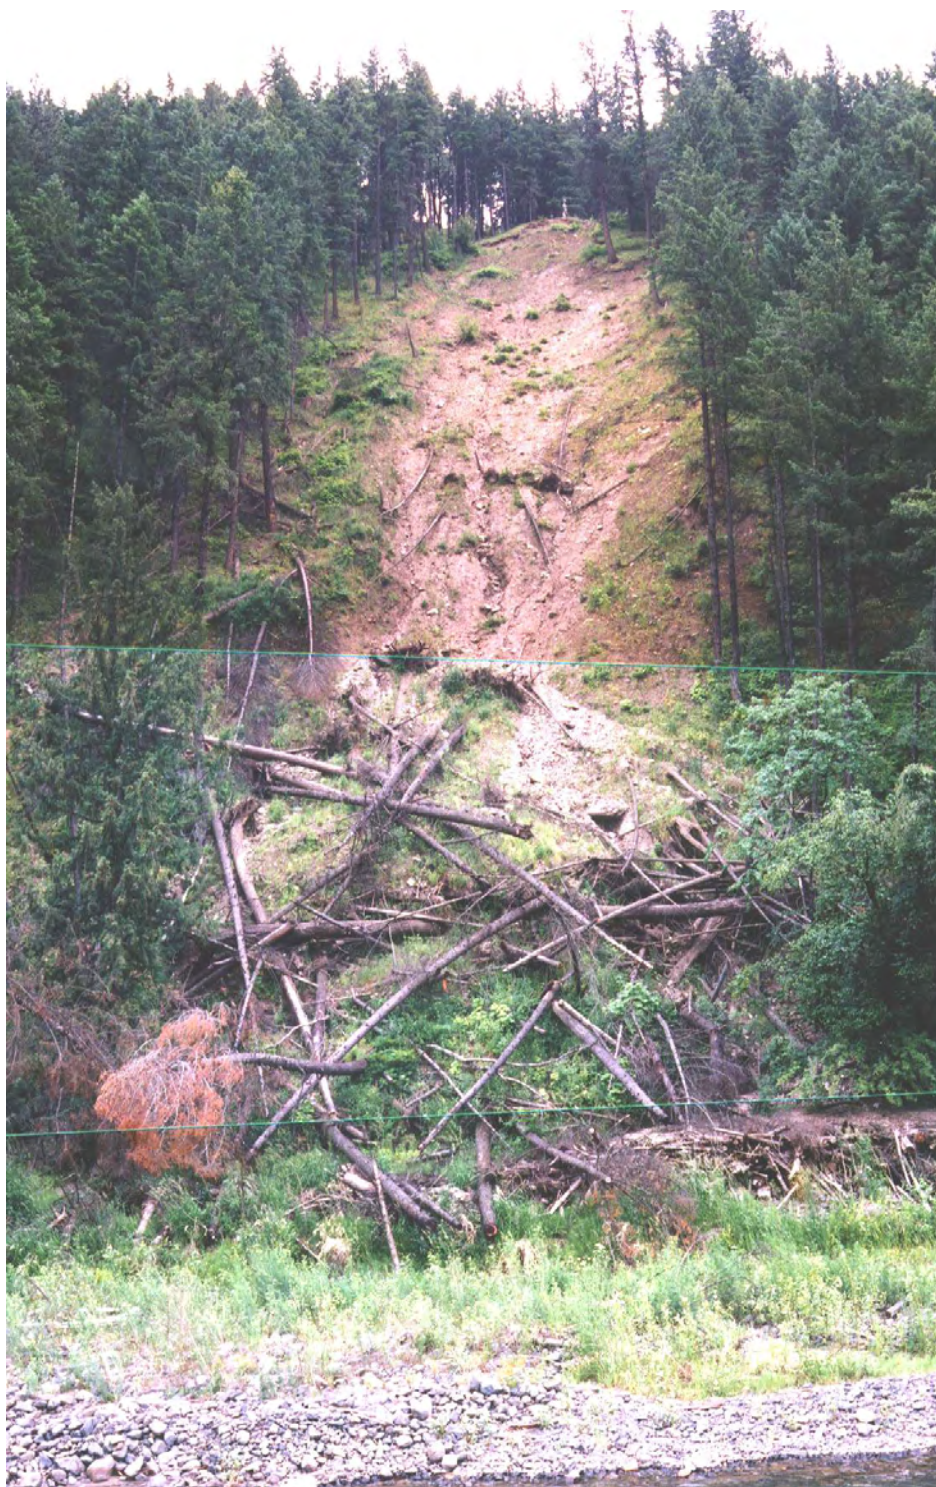
Figure 18: Photograph of Landslide at site 32. Notice pile of mixed debris at bottom of slope.

The landslide at this site is relatively large with an estimated volume of over 700 cubic feet of displaced material. Orofino Creek flows at the base of this landslide (Figure 18). The landslide that initiated at this site is on a north-facing slope. The landform here is on a slope hollow. Steepness is more than 50%. There are natural springs approximately 5 feet from the top of the landslide.

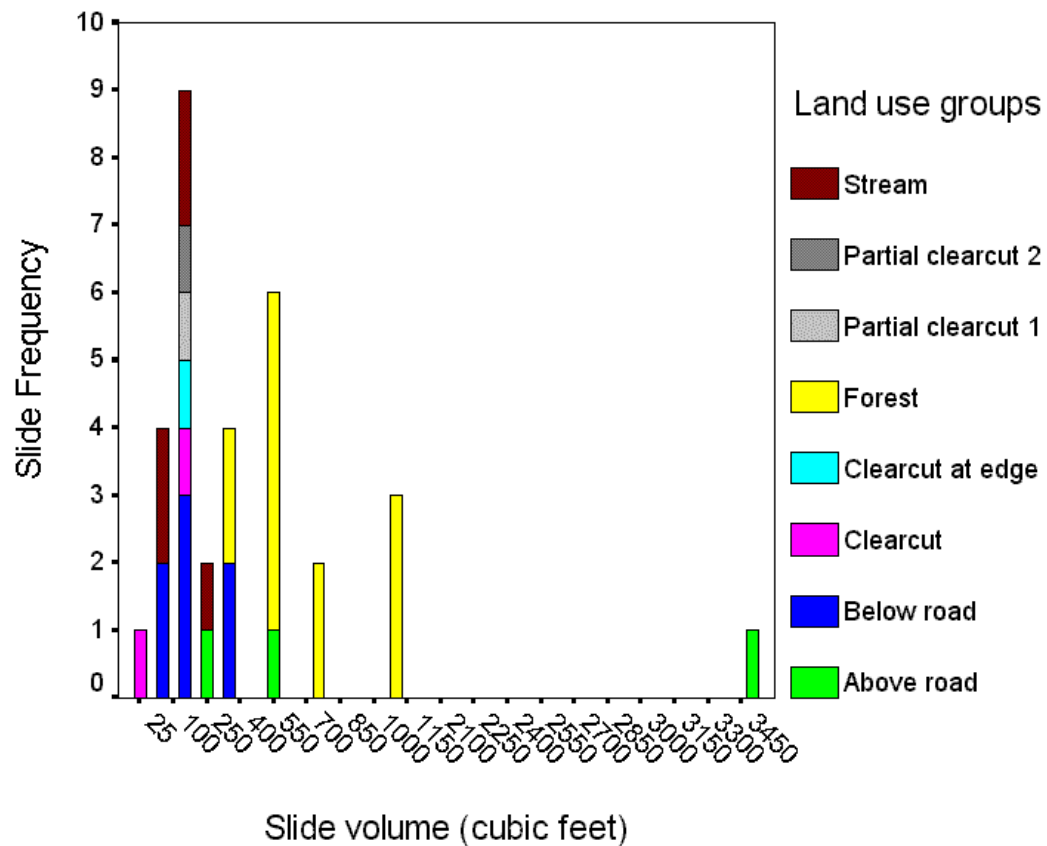
Figure 19: Landslide frequency distribution of landslide volume classes segregated into land use groups.

Schultz (1980) suggests that the large concentration of total landslide volume at the lower end of the range of landslide volumes can be attributed to the soil block being easily detached during periods of increased pore pressure. The landslides in the study area tend to follow this behavior. The average volume of landslides occurring in forested areas is comparatively higher. This is most likely caused by the increased energy needed to overcome the intrinsic strength of rooting from trees and plants. The total volume of forested landslides is still less than the total volume of landslides derived from non forested areas. This observation can be attributed to the higher frequency smaller scale sliding along roads and clearcut areas (Cacek, 1989).

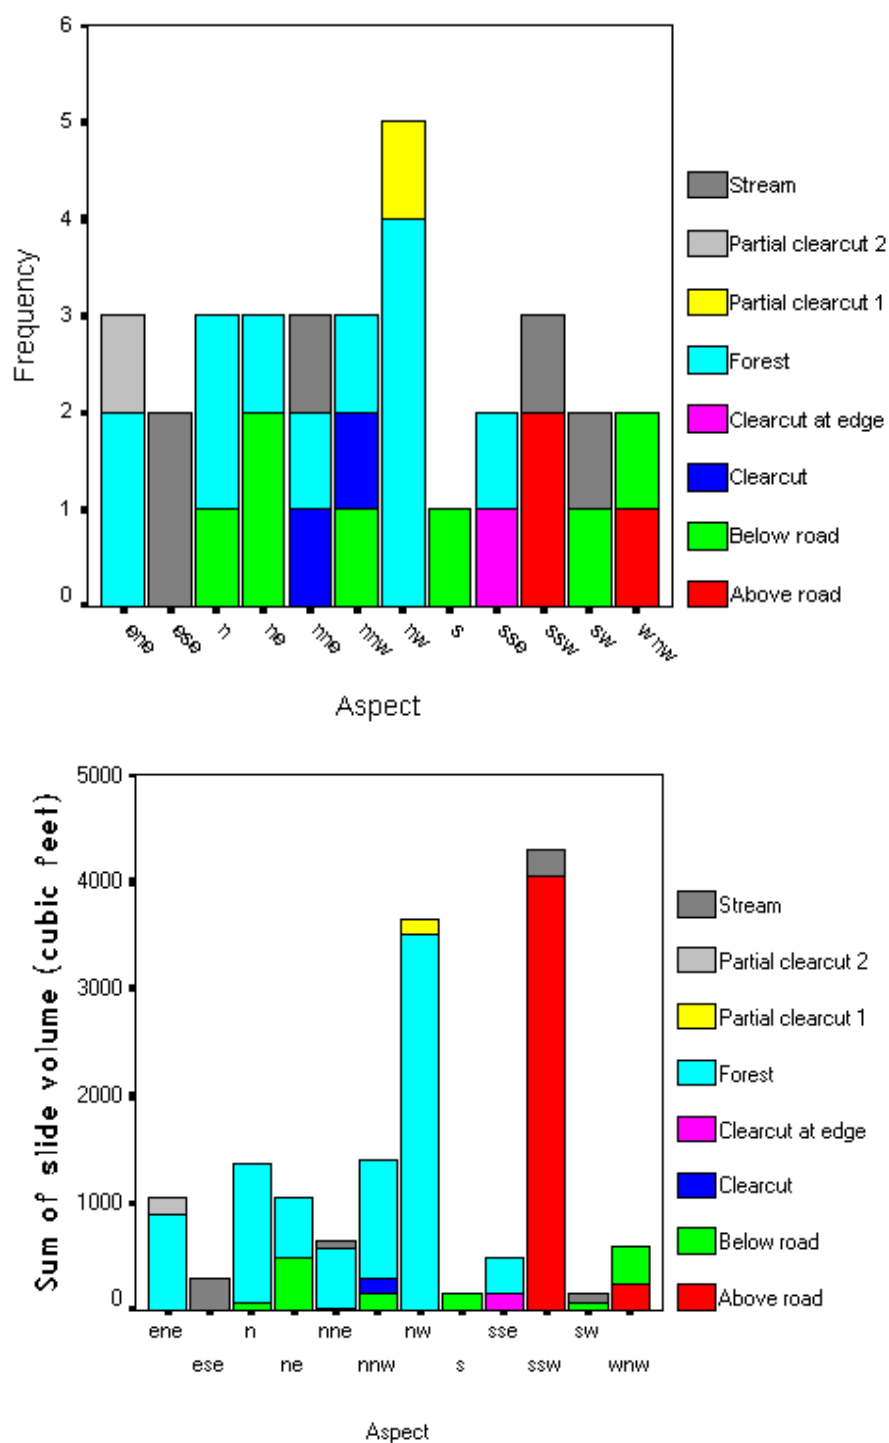
Volumetrically, forest landslides to the NW and road-impacted landslides to the SW have the highest total landslide volume (Figure 23b). The large volume in the SSW aspect is due to site 1, which has a much larger volume than any other road related site. The higher volume is due more to the fact that it is in a forested area than the presence of the road. Still, over 60% of the total landslide volume has occurred in the northern aspects. This is not unexpected since north facing slopes are generally subject to greater soil moisture retention and snowpack. During intense runoff events this greater moisture will lead to increased pore pressure and lower slope stability (Chorely and others, 1984). Aspect is most useful for landslide prediction over small areas with limited geographic diversity (Amaranthus and others, 1985).

Figure 23: Landslide a) frequency and, b) volume distributions of slope aspect segregated into land use groups.

68.6% of landslides originating with a northern component of aspect. Sites that were impacted by roads have a high landslide frequency to the southwest. Parent material type is evenly distributed on all slope aspects. Parent material does however vary locally in some places from one side of the valley to the other. This helps explain why in some areas (sites 25-32) there is landsliding on one aspect and not the opposite. Sites with geologic contacts have parent material of varied composition (basalt-colluvium-metamorphic) while in most cases across the valley the parent material is metamorphic.

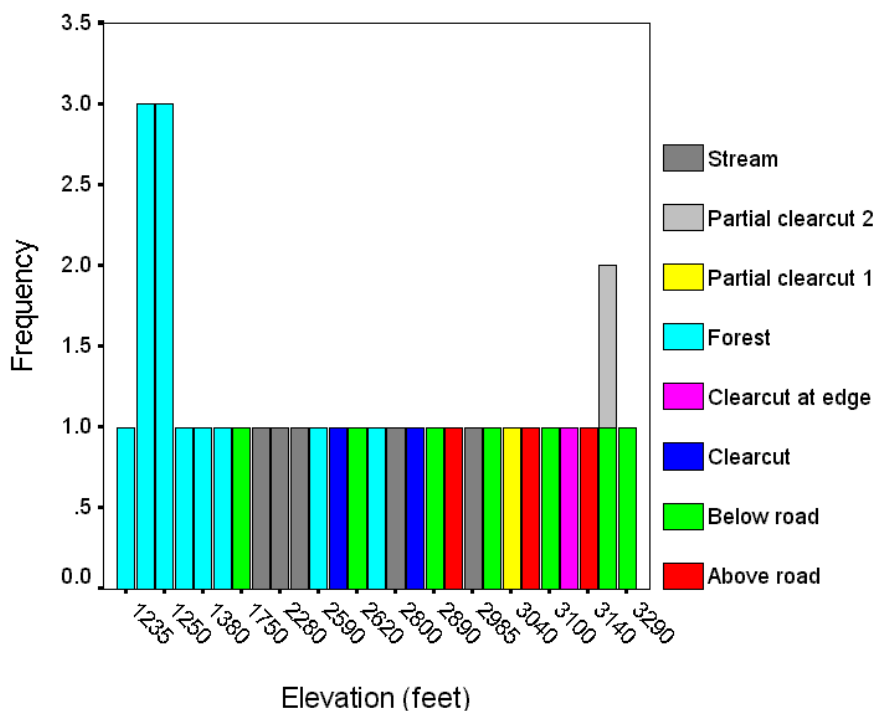
Figure 26: Landslide frequency distribution of elevation segregated into land use groups.

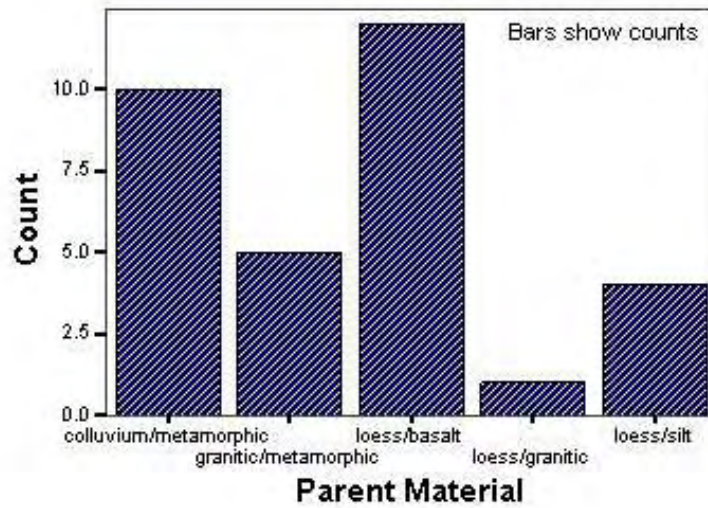
slope stability during saturated ground conditions. The greatest volume of material is associated with colluvium/metamorphic parent material type.

Figure 27: Frequency of landslide activity for each parent material type.

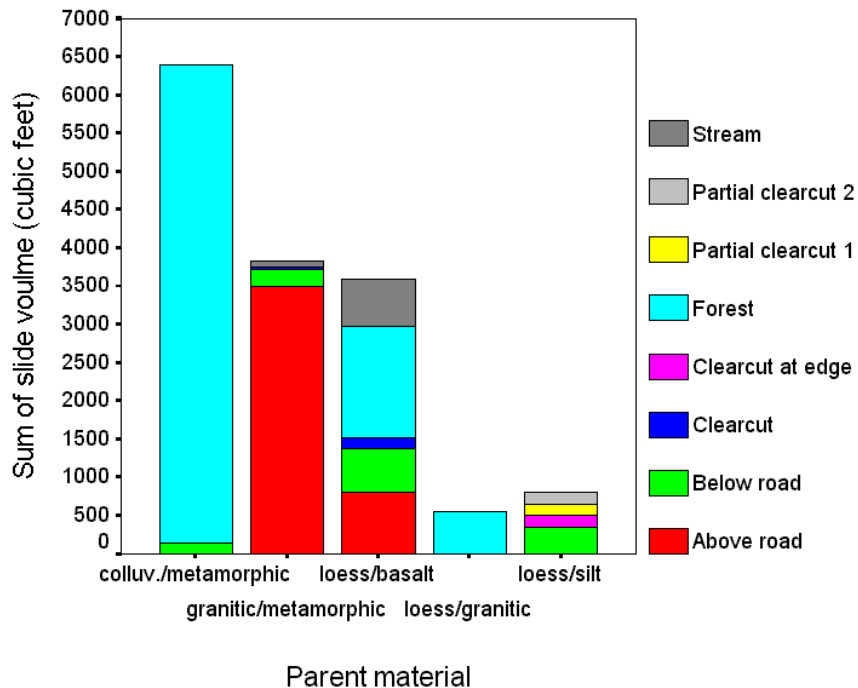
Figure 28: Landslide volume distributions of parent material segregated into land use groups.
